Subject: Arborist Report
Middlefield Road NW side at Oregon Expressway

Royston Hanamoto Alley & Abey is assisting in the design of streetscape improvements on the northwest side of Middlefield Road at Oregon Expressway, in Palo Alto. There are existing City street trees on the northwest side of Middlefield Rd. within the project limits.

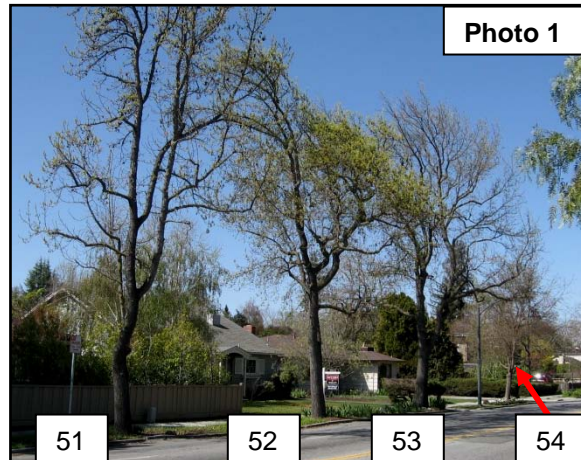
Trees #51-53 were sweetgum (*Liquidambar styraciflua*) (photo 1). Tree #51 was located on the side of 699 Oregon Ave., and #52-53 were at 2370 Middlefield Rd. The sweetgums were mature in form and development. Trunk size varied from 15" to 22" in diameter. Trees #52-53 were in good condition. They had good form and structure and a full crown. On tree #53 a 15" west facing stem over the street has been repeatedly hit by trucks creating a large wound. Tree #51 was in fair condition and characterized by a narrow form.

Chinese tallow (*Sapium sebiferum*) #54 was located at 2360 Middlefield Rd. The tree was semi-mature in development with an 11" diameter trunk. It was in good condition, had good form and a full crown (photo 1).

I recommend the removal of the remaining four (4) trees (#51-54) due to impacts from construction.

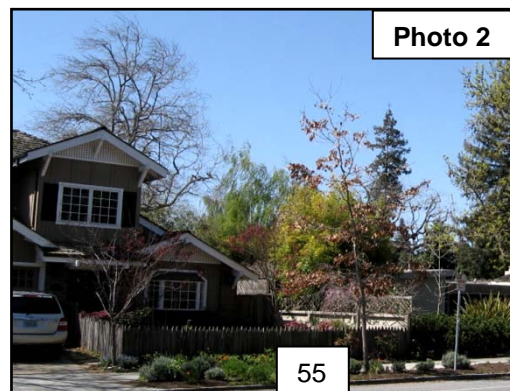
Red oak (*Quercus rubra*) #55 was located at 2342 Middlefield Rd. and was in excellent health. The young oak had excellent form and structure, and a 4" diameter trunk (photo 2). Foliage from the prior year's growth was still attached to the tree, a common characteristic of the species.

Based upon my assessment of the plans, I recommend the preservation of red oak #55. Preservation of this tree is predicated on the impacts being within the tolerances of the tree and on the implementation of specific recommendations in the ***Tree Preservation Guidelines*** (next page).
