Attachment B
Revegetation Plan

Revegetation Plan Permanente Quarry

SANTA CLARA COUNTY
CALIFORNIA

May 2010

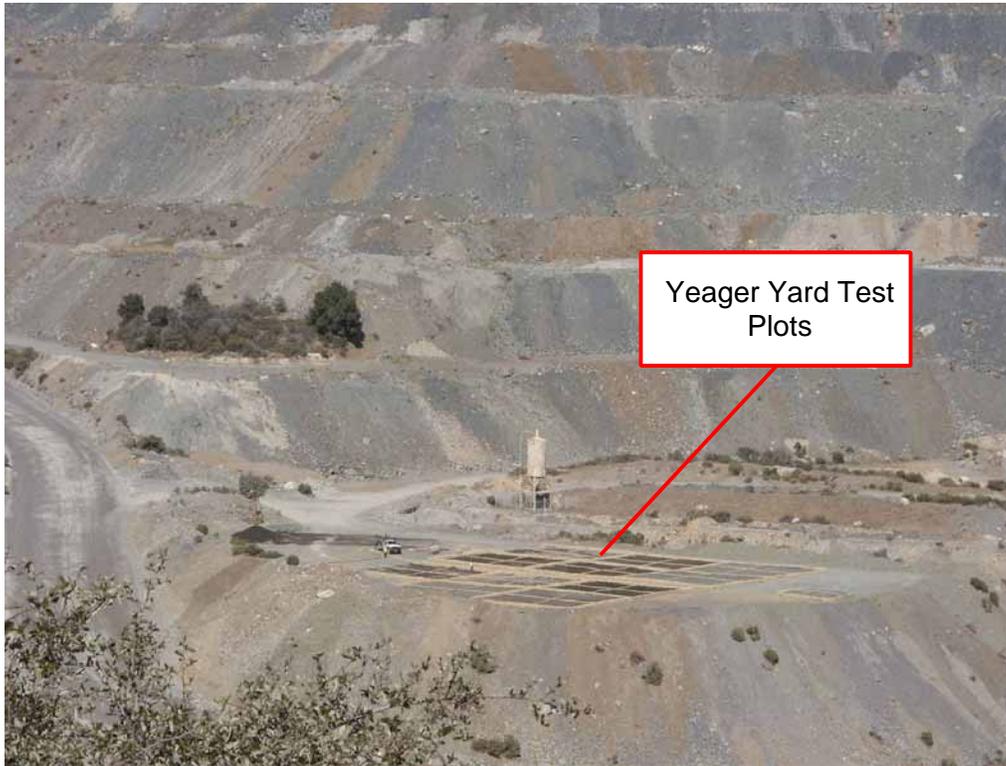
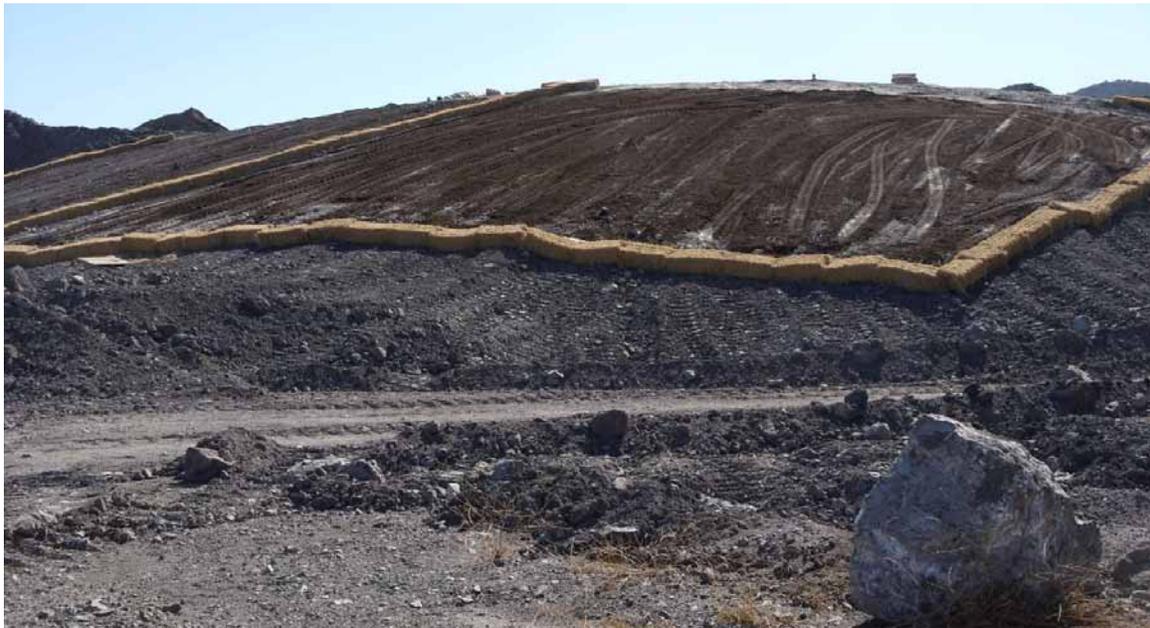
Top: Yeager Yard Test Plots (October 21, 2008)

Bottom: EMSA Test Plots (October 21, 2008)

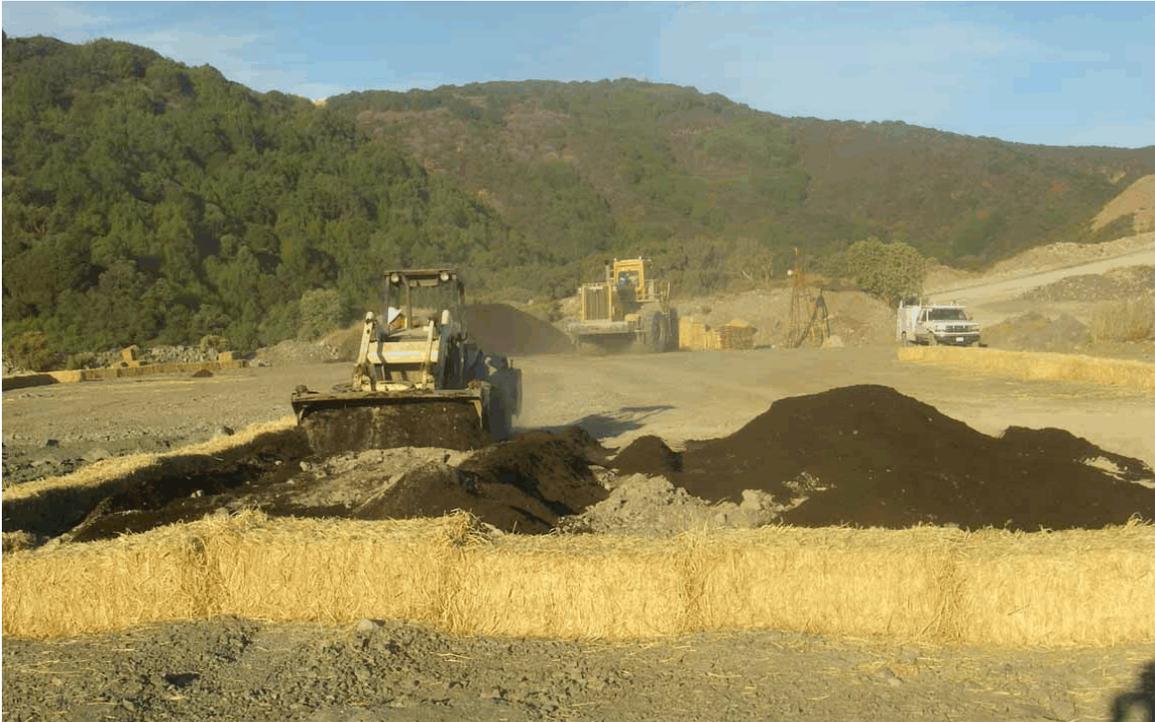
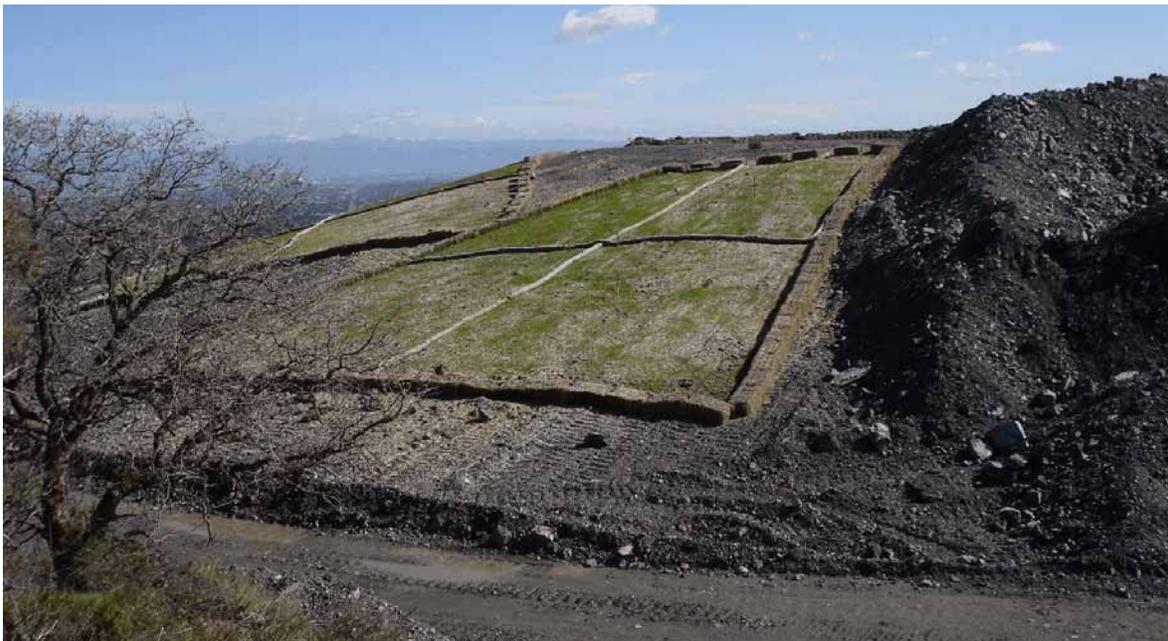
Top: Test plot construction at Yeager Yard:
Blending soil materials (October 17, 2008)

Bottom: Early spring growth of hydroseed in
the EMSA test plots (February 2, 2009)

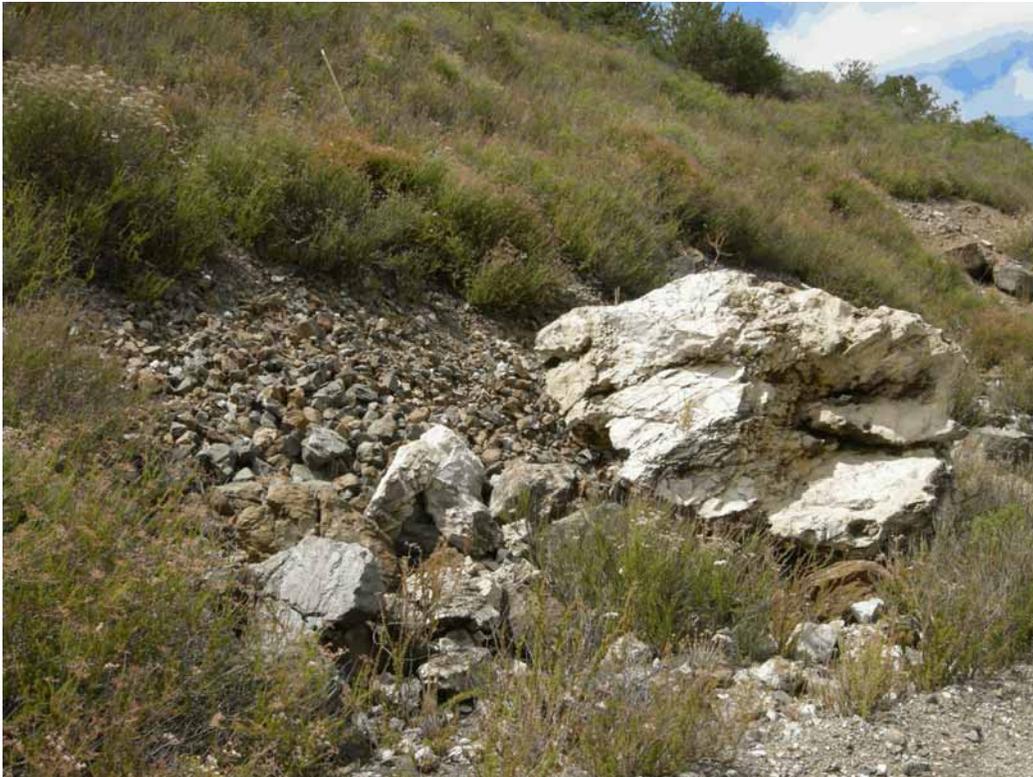
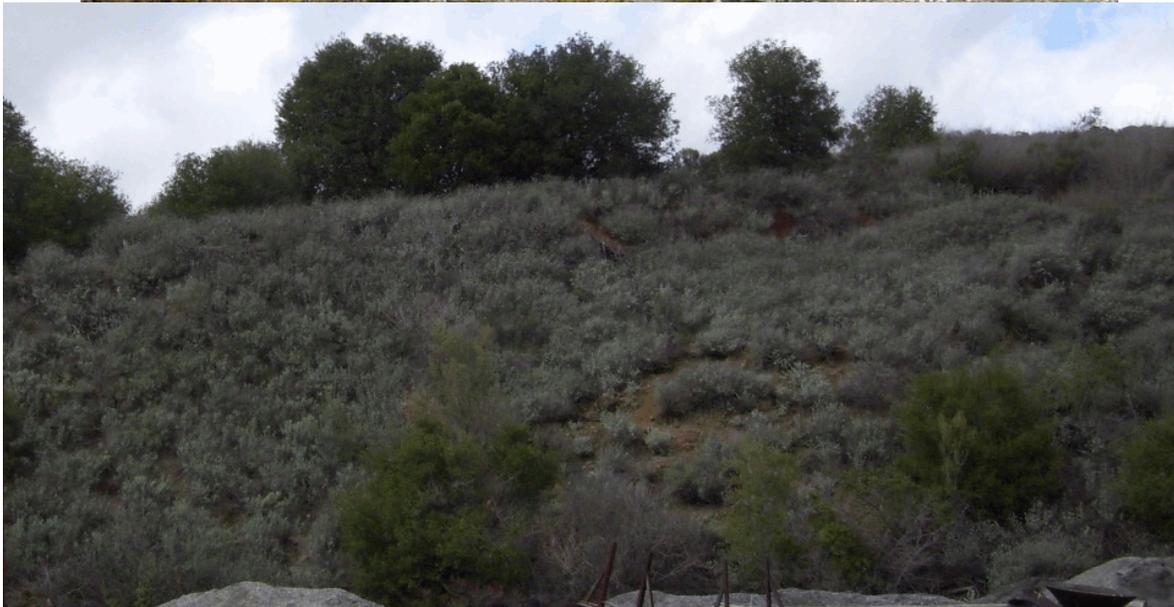
Previous successful revegetation areas supporting dense cover of native shrubs.

Top: East Quarry Revegetation area (photo May 27, 2008).

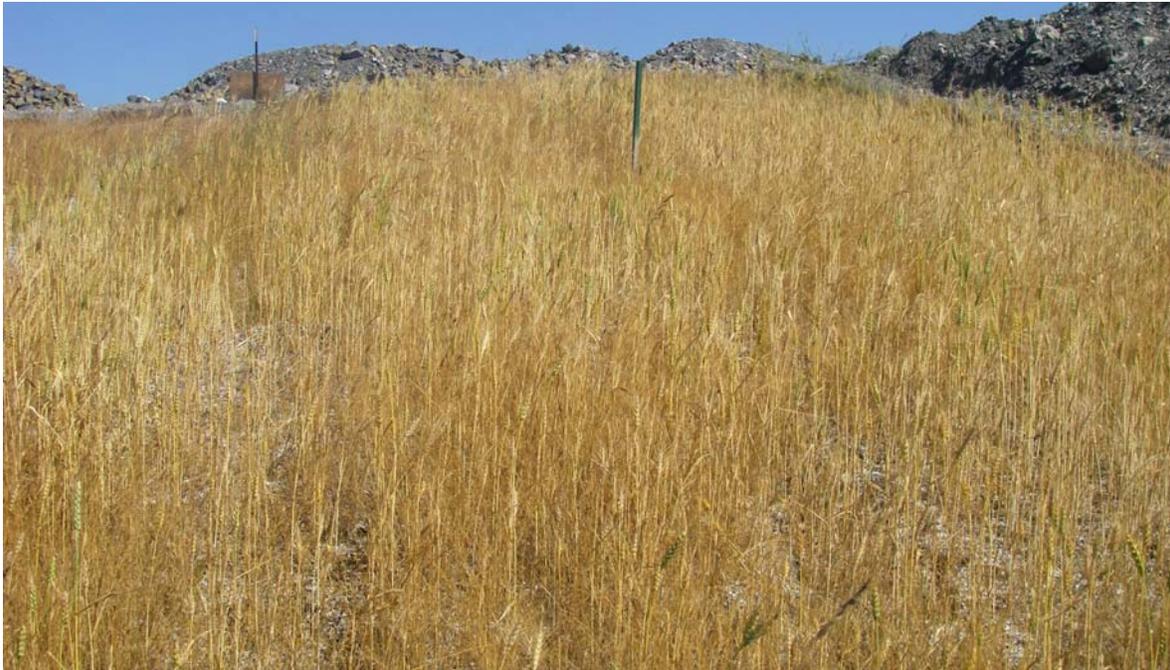
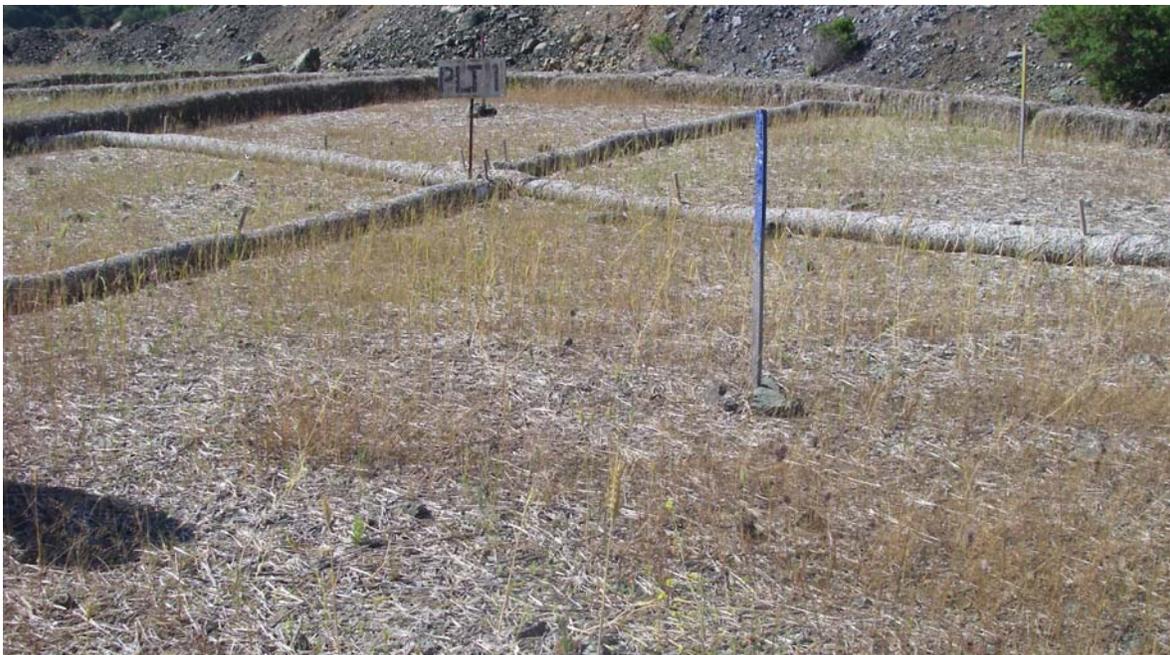
Representative Photographs – May 2009

Top: Plot 15, green seed mix. The overall plot had the highest average native species cover (33%, mostly *Vulpia microstachys*). This quadrant had an average cover of 31% natives and 9% non-natives (mostly sterile wheat).

In Year 1, the difference in seed performance and cover of native species between soil treatments was generally minimal. Average cover of native species ranged from 6.5% to 17.7%, with the exception of Plot 15. Plot 15, a sloped plot containing a mix of 75% North Quarry Fine Greenstone and 25% compost, supported 32.9% average cover of native species. However, the higher native cover was provided by only one annual grass species, small fescue (*Vulpia microstachys*), a standard component in native erosion control mixes.
